Research Progress and Accomplishments

MCEER-01-SP01

Seismic Evaluation and Retrofit of the Ataturk International Airport Terminal Building

by Michael C. Constantinou, Andrew S. Whittaker and Emmanuel Velivasakis

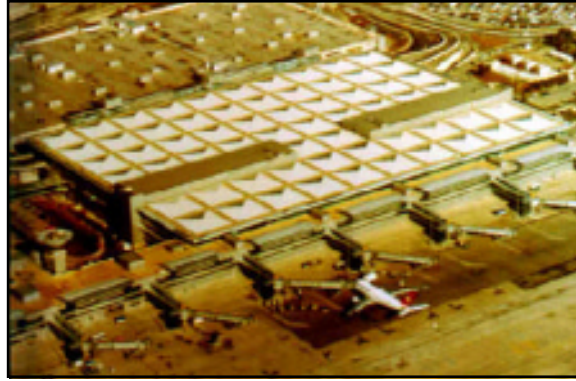
At the time of the August 19, 1999, Izmit earthquake, the new Ataturk International Airport Terminal building was nearing completion. The airport, which is located 25 km from the center of Istanbul, was shaken and damaged by the earthquake. (The airport is located approximately 70 km from the fault rupture plane.) The new Terminal building is a three-story reinforced concrete building with a space-frame roof. The plan footprint is approximately 240 m by 168 m. A view of the terminal building is presented in Figure 1.

■ **Figure 1.** New Ataturk International Airport Terminal Building

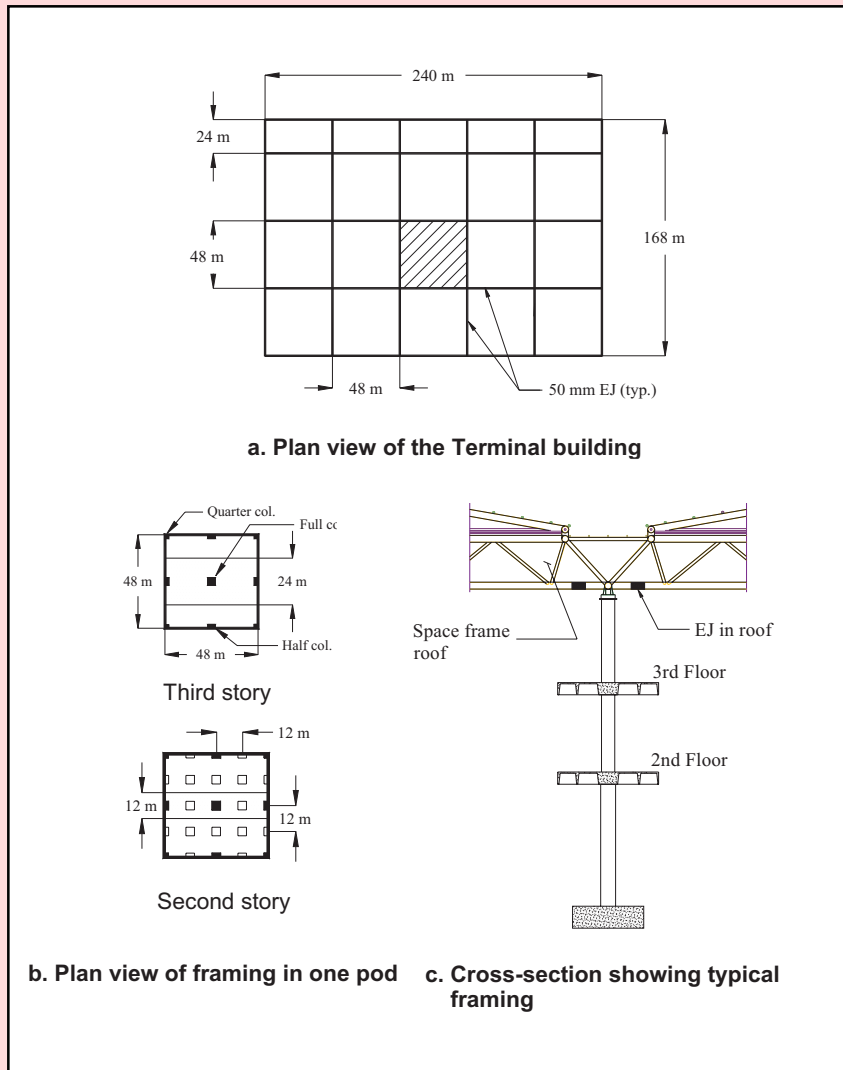
■ Figure 2. Construction of the Terminal Building

The lowest story of the building provided mechanical and baggage handling services. The second and third stories of the building housed the Arrivals and Departures Halls, respectively. A plan view of the building is shown in Figure 2a. As shown in Figure 2a, the 240 m by 168 m building is composed of 20 pods (or independent frames); the typical pod dimension is 48 m by 48 m. A typical pod is shown shaded in this figure. The pods were separated by 50 mm wide expansion joints (EJs). Figure 2b shows the framing in the third and second stories of a typical pod; the framing in the first story was similar to that in the second story. Figure 2c is a cross-section through the build-

ing showing typical framing. The building is framed in reinforced concrete. Above the third floor level, cantilever columns on 24 m centers supported a three-dimensional steel space-frame roof structure. The space-frame roof was equipped with sleeved movement joints to permit thermal expansion and contrac-

tion of the roof. These movement joints did not align with the expansion joints in the reinforced concrete framing. At the third floor and below, gravity loads were supported by reinforced concrete waffle slabs and columns at 12 m on center. Lateral loads were resisted by waffle-slab moment-frame construction in each direction. Solid beams of a depth equal to that of the waffle slab spanned between the columns. Around the perimeter of each pod, the column sizes were substantially reduced from those in the interior of the pod. At the corners of each pod, the four columns were approximately square but with dimensions one-half of those of the interior columns (and called

quarter columns in this paper). Along each edge of each pod, and between the corner quarter columns, the columns were approximately rectangular and half the area of the typical interior columns (and called half columns in this paper.)
